Water flow between Ohau Channel and Lake Rotoiti following implementation of a diversion wall

CBER Contract Report 96

Prepared for Environment Bay of Plenty

March 2009

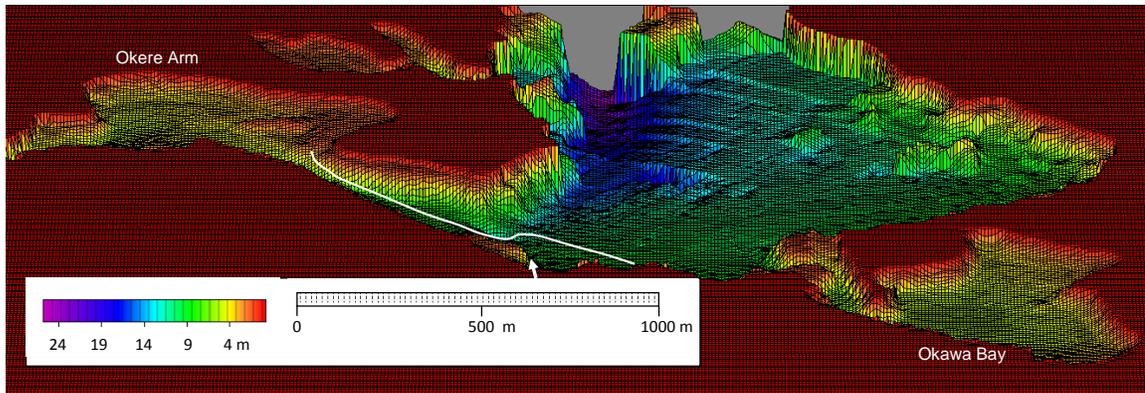
Figure 1. Bathymetry of the western end of Lake Rotoiti showing the entrance of the Ohau Channel (white arrow) and the diversion wall (white line). The main basin of Lake Rotoiti is in the mid-upper. The left-hand coloured bar shows water depth and the right-hand bar shows an approximate width scale. The Kaituna outlet of Lake Rotoiti is further to the left of the figure, beyond the Okere Arm.

The focal point for this study was the end of the Ohau Diversion Wall and the Okere Arm of Lake Rotoiti (Figures 1 and 2). This study site is incorporated into a larger lake setting through use of BioFish data collected along a transect from Ngongotaha in Lake Rotorua, through the Ohau Channel and into the eastern end of Lake Rotoiti (Figure 2). The diversion wall begins on the western side of the Ohau Channel entrance and runs parallel to the lake edge for 1,275 m, forming a diversion channel of width approximately 75 m. North-east of the diversion channel exit is Kaituna River, the outlet for Lake Rotoiti (Figure 1).

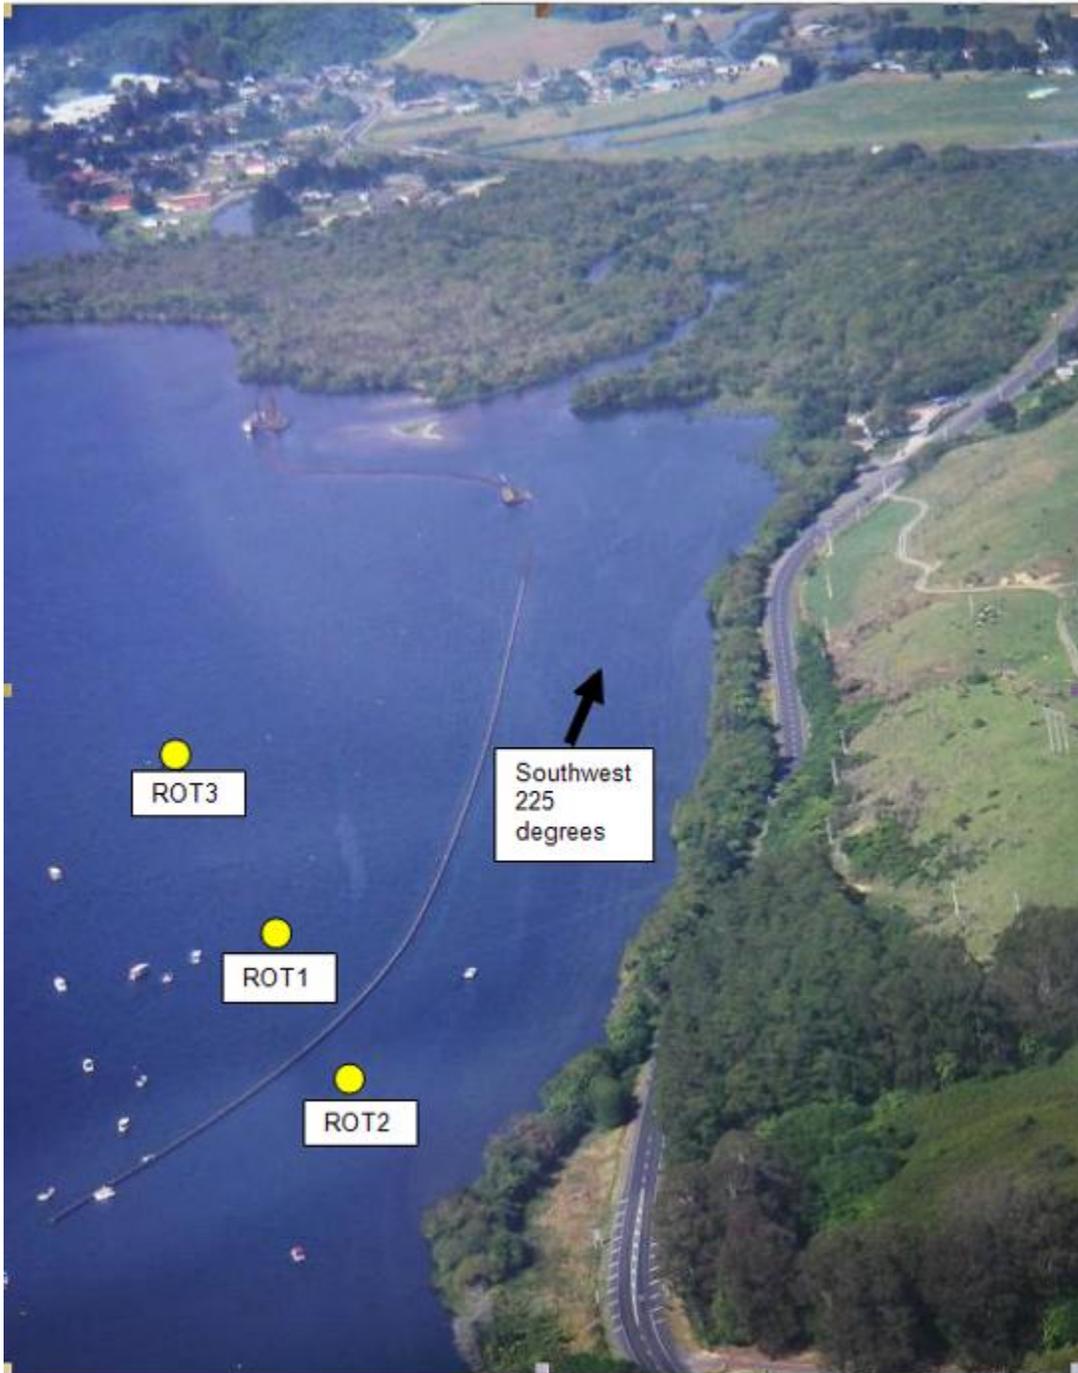
Figure 2. Location of current meters installed from 20 Aug to 9 Sept 2008 at sites ROT1, ROT2 and ROT3. The black arrow denotes a directional marker (not the current direction which was aligned almost 180° opposite).

The speed of flow, direction of flow and temperature measurements used in this report were collected with current meters (Sontek ADV Triton) installed at three sites from 20 August to 9 September 2008 (Figure 2). Each meter was positioned just above the lake or channel bed. Site 1 (ROT1) was located at a water depth of 6 m on the Lake Rotoiti side of the diversion wall; site 2 (ROT2) at a water depth of 5 m within the diversion channel and site 3 (ROT3) at a water depth of 9.5 m on the Lake Rotoiti side of the diversion wall but further from the wall than ROT1 (Figure 2). Data were recorded at intervals of 15 minutes.

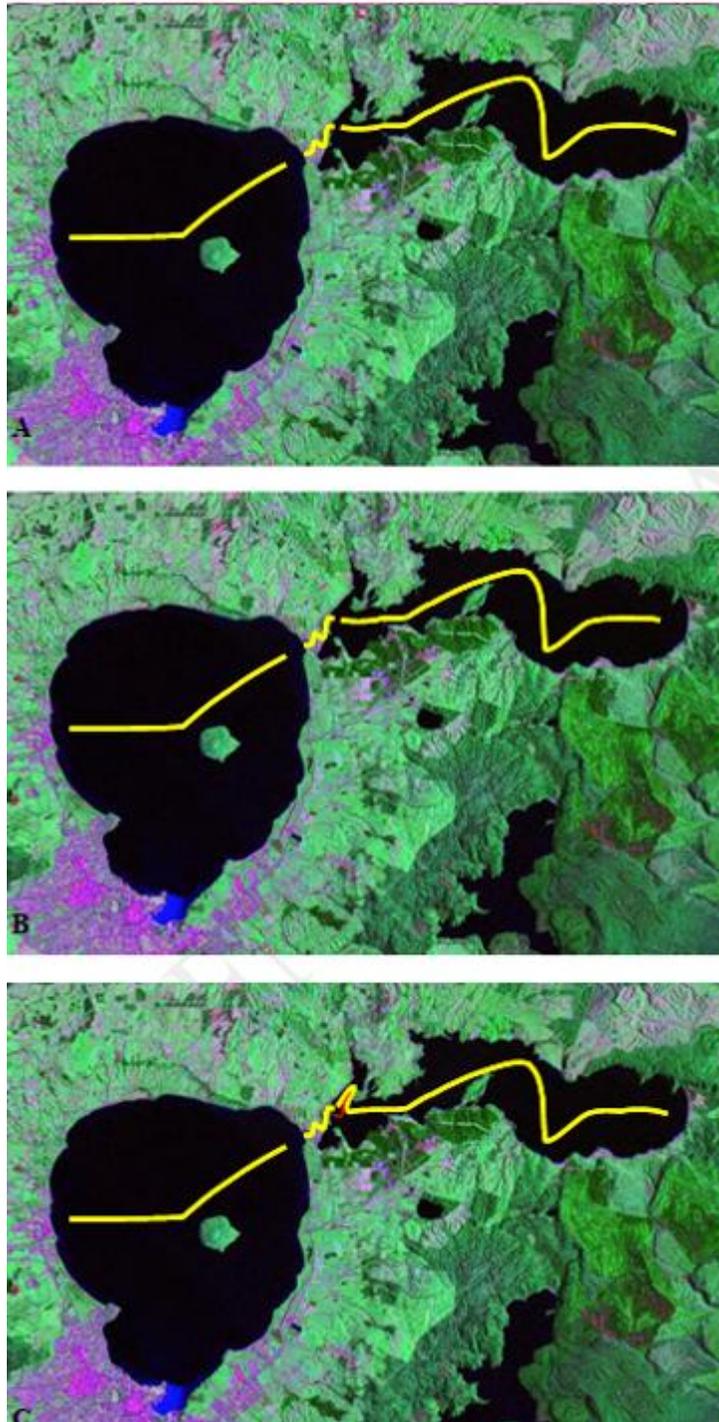
Figure 3. Transect of the BioFish from Ngongotaha at the western end of Lake Rotorua, through Ohau Channel to the eastern end of Lake Rotoiti (A) 11 August 2006 (B) 29 August 2007 (C) 26 August 2008. ✓ denotes the diversion wall.

Water temperature, conductivity, dissolved oxygen, chlorophyll fluorescence and conductivity data used in this report were obtained from monthly surveys using a BioFish (ASD Sensortechnik GmbH, Germany). These data were collected at 4 Hz whilst the instrument was towed behind a boat, undulating in a vertical path. A transect was made within Lake Rotorua, through surface waters in the shallow Ohau Channel and then into Lake Rotoiti. Precise location of the BioFish was obtained through the combination of GPS on the boat and a pressure transducer on the instrument. The pathway followed on 11 August 2006 and 29 August 2007 was a transect from Ngongotaha in Lake Rotorua, through the Ohau Channel, into the western basin of Lake Rotoiti, then proceeding to the eastern end of the lake (Figures 3A and 3B). The path taken on 26 Aug 2008 included through the channel within the diversion wall but otherwise remained largely the same as in 2006-7 (Figure 3C). Each survey started at 10:00 hr and was concluded by 14:00 hr. Data from the BioFish surveys were graphed with Ocean Data View (Version 3.3.2, 2007).

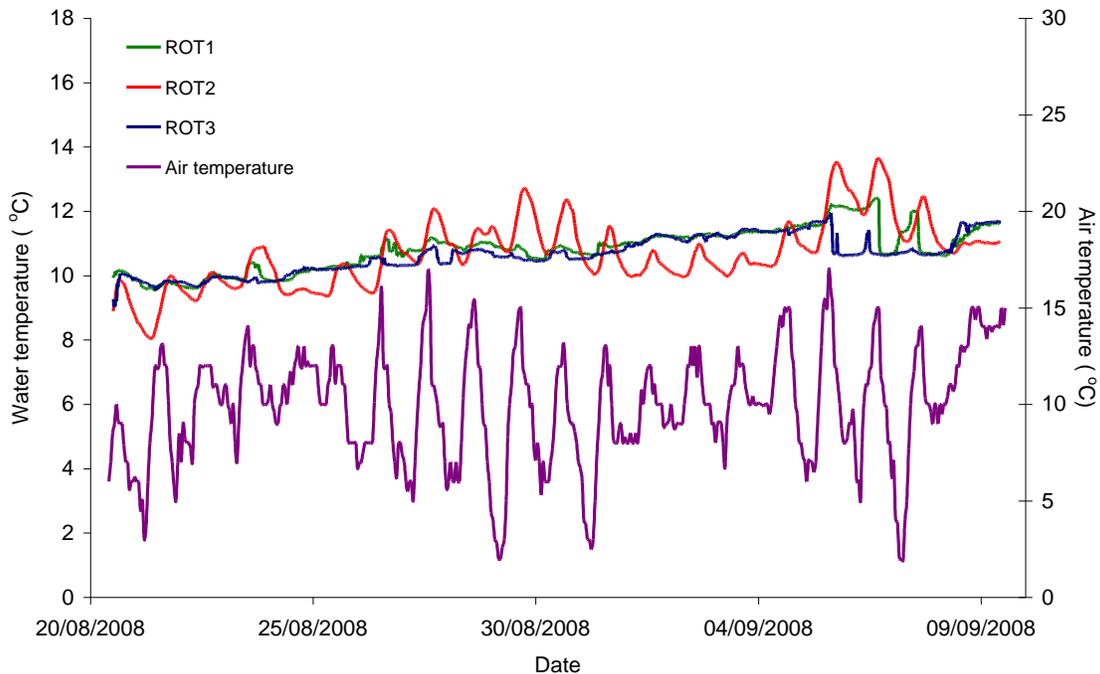
The mean water temperature for ROT1, ROT2 and ROT3 was very similar at 10.8, 10.7 and 10.6 °C, respectively (Figure 4). However, short term variations in temperature between sites were much greater. ROT2, the site within the diverted Ohau Channel, varied most from ROT1 and ROT3 (sites within Lake Rotoiti). The range of temperatures recorded at ROT2 was 8.0-13.7 °C, whereas ROT1 was 9.5-12.4 °C and ROT3 was 9.0 – 12.0 °C. There were periods when ROT2 varied strongly with both ROT1 and ROT3, with the greatest temperature difference of nearly 3 °C recorded on 6 September 2008 between the Ohau Channel site (ROT2) and the Lake Rotoiti sites (ROT1 and ROT3). Water temperatures were ≥ 0.5 °C between ROT2 (Ohau Channel) and ROT1 and ROT3 for 35% and 36%, respectively, of all measurements.

Figure 4. Temperature measured by current meters at sites ROT1, ROT2 and ROT3 and air temperature measured at Rotorua Airport, 20 August to 9 September 2008.

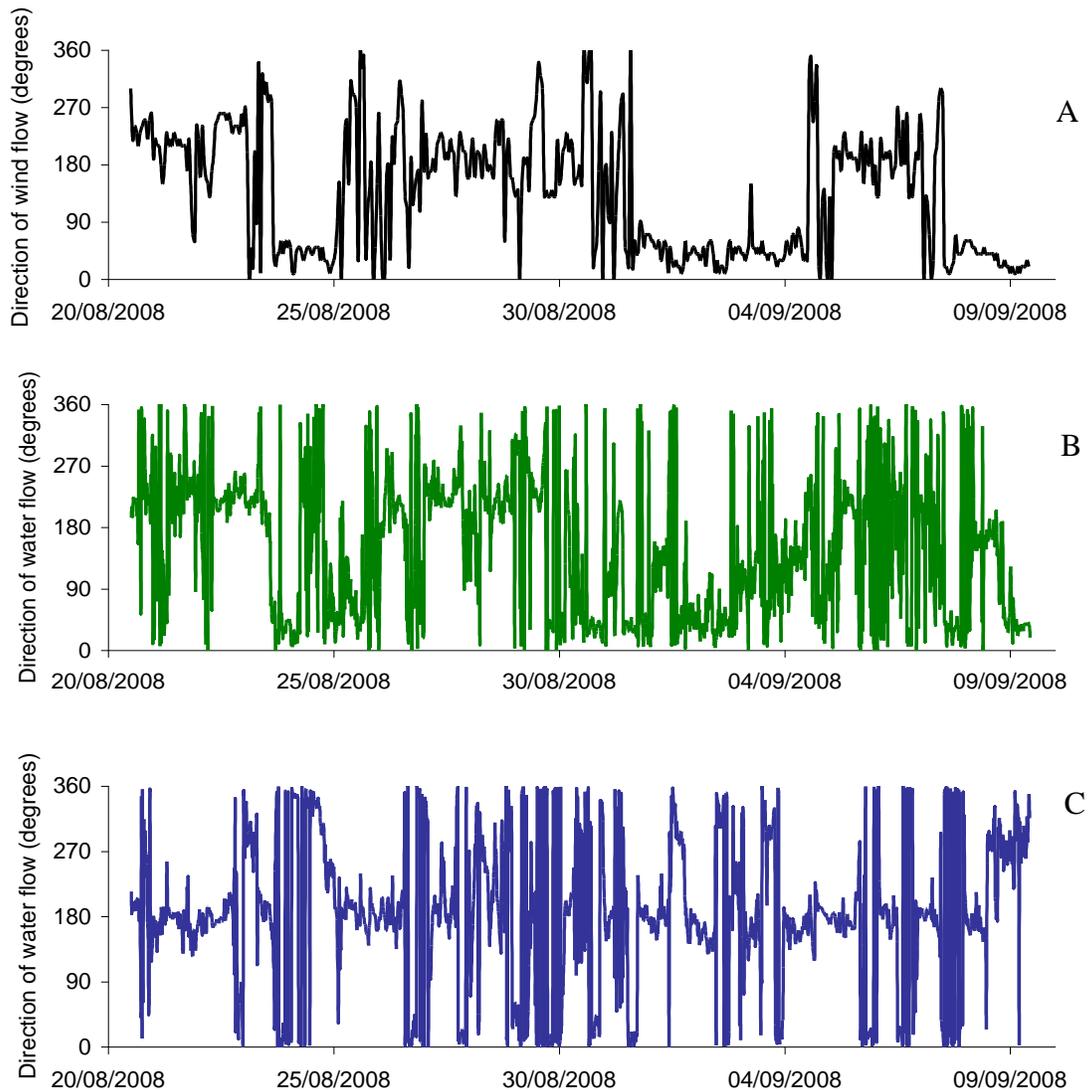
The direction of flow at ROT2 was always north-east (NE), aligned with the diversion wall and towards the Kaituna River (Table 1 and Figure 5). At ROT1 in Lake Rotoiti water flow was NE towards the Kaituna River for 38% of the time and SW towards Lake Rotoiti for 33% of the time, while at the deeper site (ROT3) flow was in the direction of Lake Rotoiti for 29% of the time (Table 1).

Figure 5. Wind and water current directions for 20 August to 9 September 2008. (A) Hourly wind direction measured at Rotorua Airport, and current flow direction (15 minute intervals) at (B) ROT1 (C) ROT3.

There was some correspondence of water flow direction at ROT1 and ROT3 during periods of sustained, relatively constant wind direction, but with periodic interruptions and reversals of flow at the two lake monitoring stations.

The highest wind speed of recorded at Rotorua Airport during the period of current meter deployment was 13.9 m s^{-1} on 24 August 2008. Wind came mainly from the north-east and south directions (Figure 6). The wind direction at Rotorua Airport and the current direction at both ROT1 and ROT3 showed rough correspondence, especially at ROT 1 (Figures 5, 6 and 7).

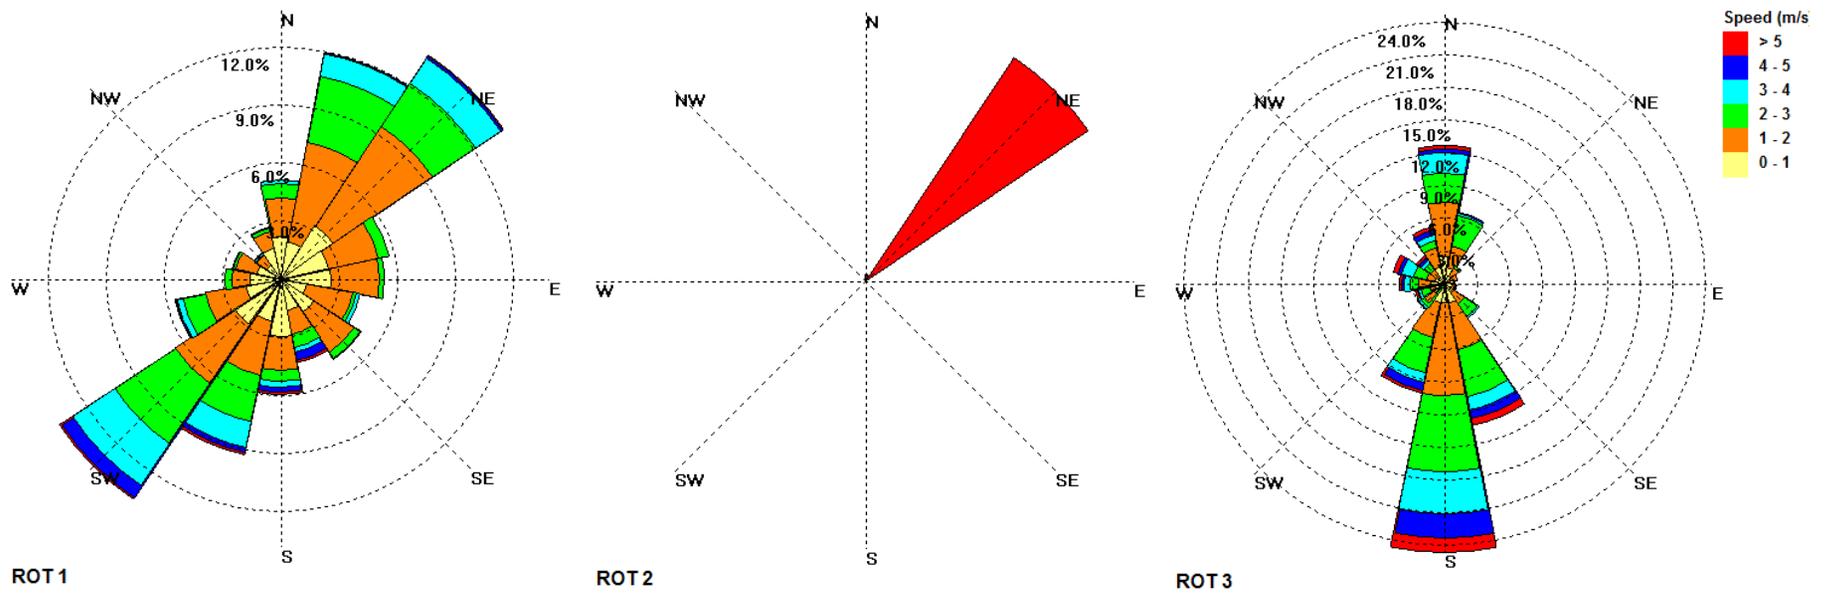
Higher values of current speed at the Lake Rotoiti stations (ROT1 and ROT3) tended to be associated with water flow in south-west (SW) or north-west (NW) directions. A summary of current speeds at the three sites is shown in Figure 6. Current speeds at ROT2 (within the diversion wall) were higher than those in Lake Rotoiti (ROT1, ROT3) in all but one instance. Mean current speed during sampling was 14.1 cm s^{-1} at ROT2 and 1.6 and 2.1 cm s^{-1} at ROT1 and ROT3, respectively. Current speed range was $0.01\text{-}14.03 \text{ cm s}^{-1}$ at ROT2, $8.4\text{-}21.4 \text{ cm s}^{-1}$ at ROT1 and $0.02\text{-}9.4 \text{ cm s}^{-1}$ at ROT3. The maxima of the range corresponded to dates of 7 September at ROT1, 6 September at ROT2, and 3 September at ROT3.

Figure 6. Summary of water current speeds and directions from data taken at 15 minute intervals 1 m above the lake bed at sites ROT1, ROT2 and ROT3. Percentages based on 15-minute readings from 20 August to 9 September 2008.

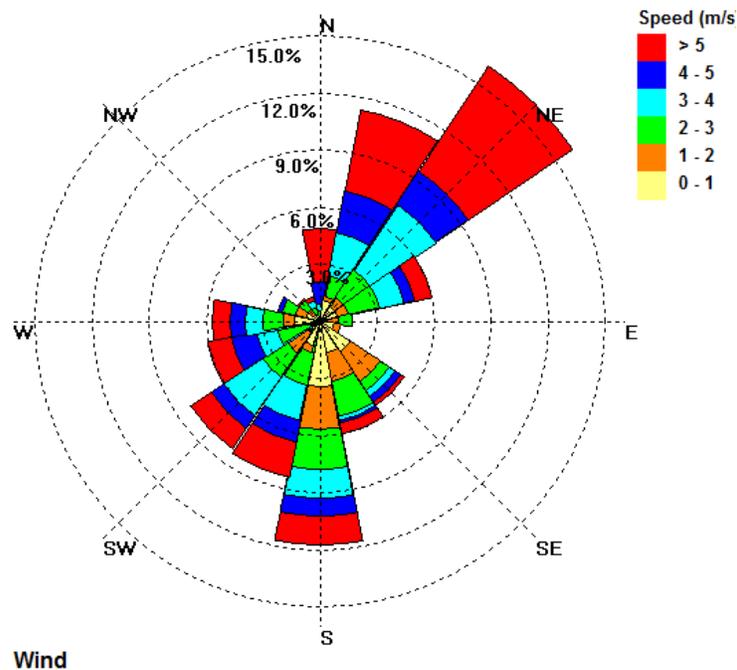
Figure 7. Hourly wind direction and wind speed at Rotorua Airport for 20 August to 9 September 2008.

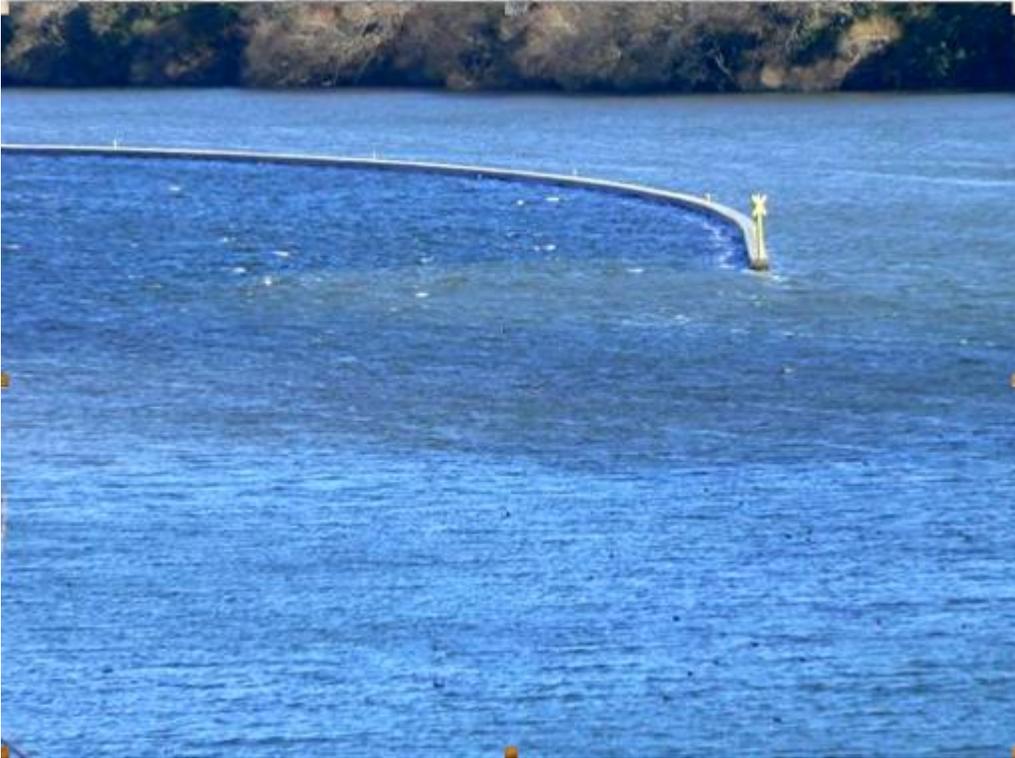
Figure 8. Photo of the end of Ohau Channel Diversion wall taken 13:40 hr on 24 July 2008. Note relatively turbid water from the diversion channel (left-hand side of photo) flowing into relatively clear water of Lake Rotoiti. Photo courtesy of N. Miller.

Our measurements have been supplemented with five cases of visual evidence of the plume. The first is a photo of the south-east end of the Ohau Channel at 13:40 hr on 24 July (Figure 8). The second is a satellite sensing image taken on 17 November 2008 (Figure 9). The photo on 24 July shows relatively turbid water from the Ohau Channel tending to spread laterally once it flows past the end of the diversion wall. At 14:00 hr on this day the wind speed was 7.7 m s^{-1} and wind direction was south-west at Rotorua Airport. The remote sensing image was from 17 November 2008. It shows a marked difference in water clarity between the turbid diversion channel water and the clear waters of Lake Rotoiti (Figure 9). The water from Lake Rotoiti can be discerned well past the end of the diversion wall and into the Okere Arm end of the lake. Three other aerial photos from 16 December 2008 are shown to provide additional perspective on the diversion wall (Figures 10, 11 and 12).

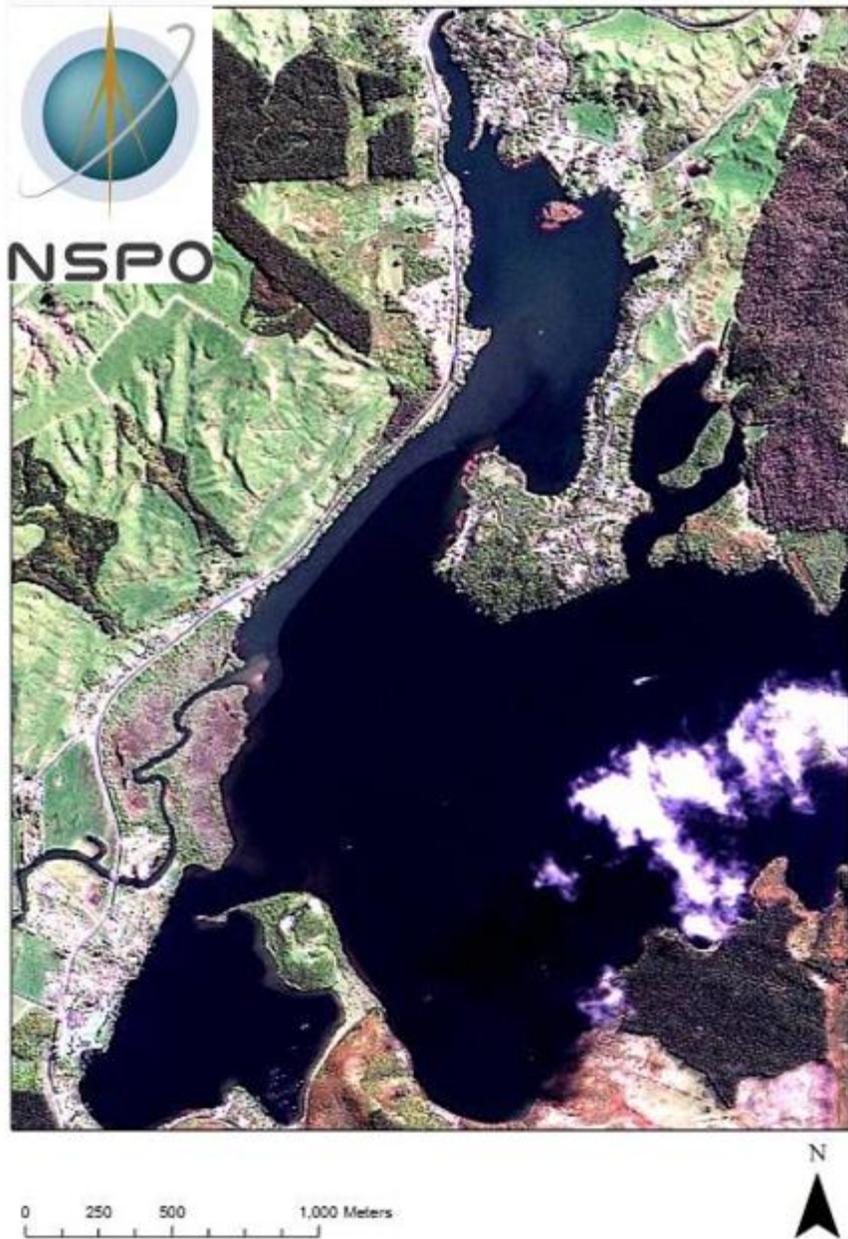
Figure 9. Remote sensing image of Ohau Channel, Okawa Bay, Kaituna exit and western basin on Lake Rotoiti. Photo taken 17 November 2008. Image made available through agreement entered into for the license from National Space Program Office of the National Applied Research Laboratories for the limited use of ROCST-2 satellite image and data by the University of Waikato, and supported through the Global Lake Ecological Observatory Network (GLEON). The horizontal resolution is 2 m and the image has been pan-sharpened from a true colour image through assistance from Mat Allan (University of Waikato).

A satellite sensing image of the western end of Lake Rotoiti on 17 November 2008 shows a marked difference in water clarity between the relatively turbid diversion channel water and the clear waters of Lake Rotoiti. On this occasion the water from Lake Rotoiti can be discerned well past the end of the diversion wall and into the Okere Arm region of the lake.

The satellite image (Figure 9), shows turbid water within the diversion channel moving past the end of the diversion wall and into the Okere Arm. This is in contrast to the clear waters of Lake Rotoiti and is visual evidence that the diverted water was flowing towards Kaituna River at this time. Overflow conditions were most likely to have been prevalent at the time of the satellite photo in November (Gibbs *et al.* 2003; Hamilton *et al.* 2005).

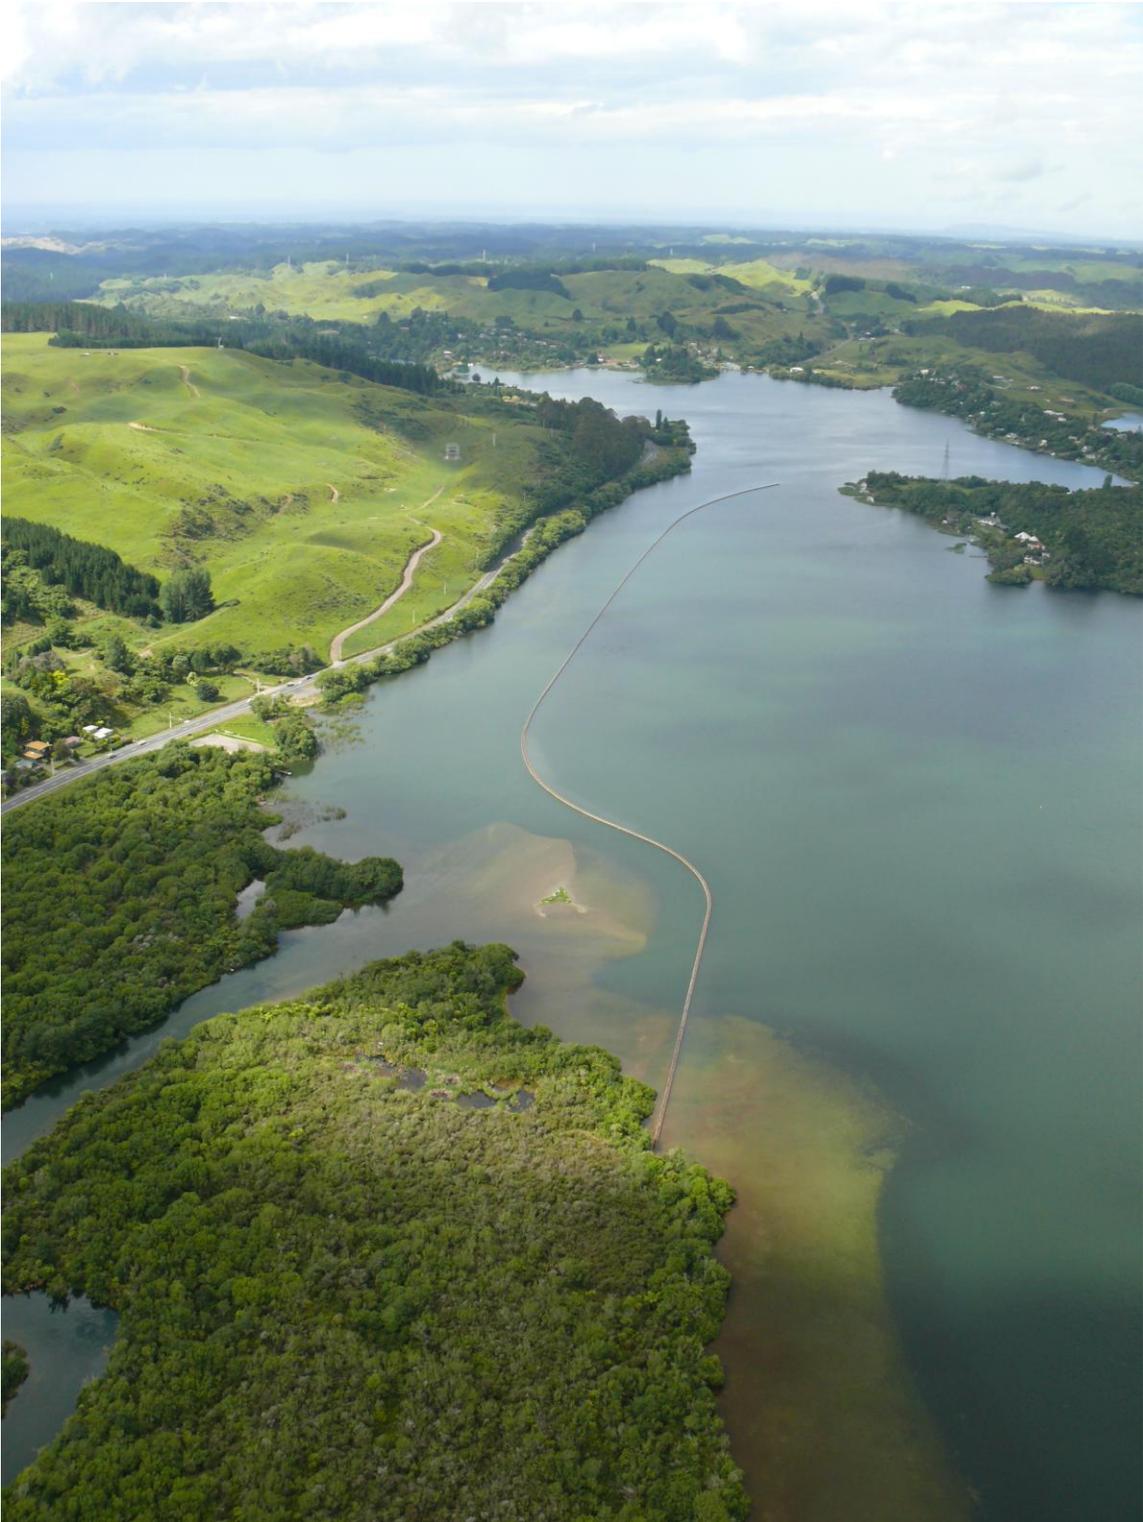
Figure 10. Photo of the Ohau Channel diversion wall showing the Okere Arm towards the outlet of Lake Rotoiti (upper left). Photo: Environment Bay of Plenty.

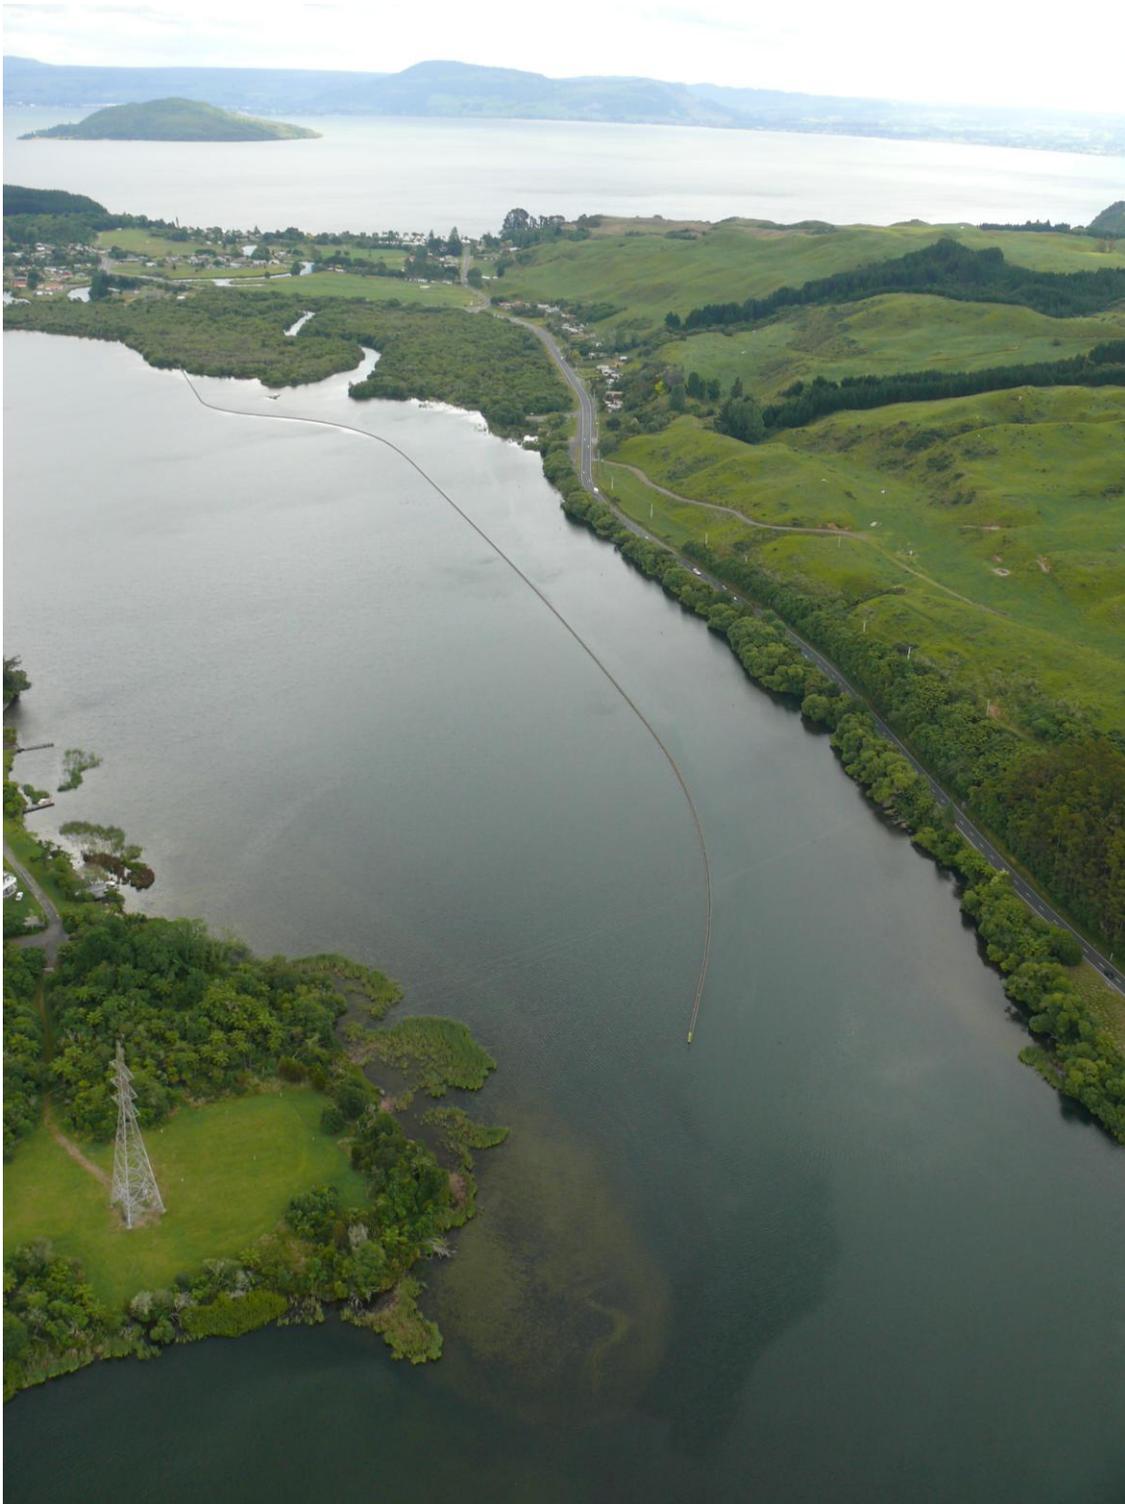
Figure 11. Photo of the Ohau Channel diversion wall, also showing Lake Rotorua (top waterbody) and including Mokoia Island (upper left). Note the variation in water appearance between in the photo foreground arising from mixing between water from the Ohau Channel from Rotoiti. Photo: Environment Bay of Plenty.

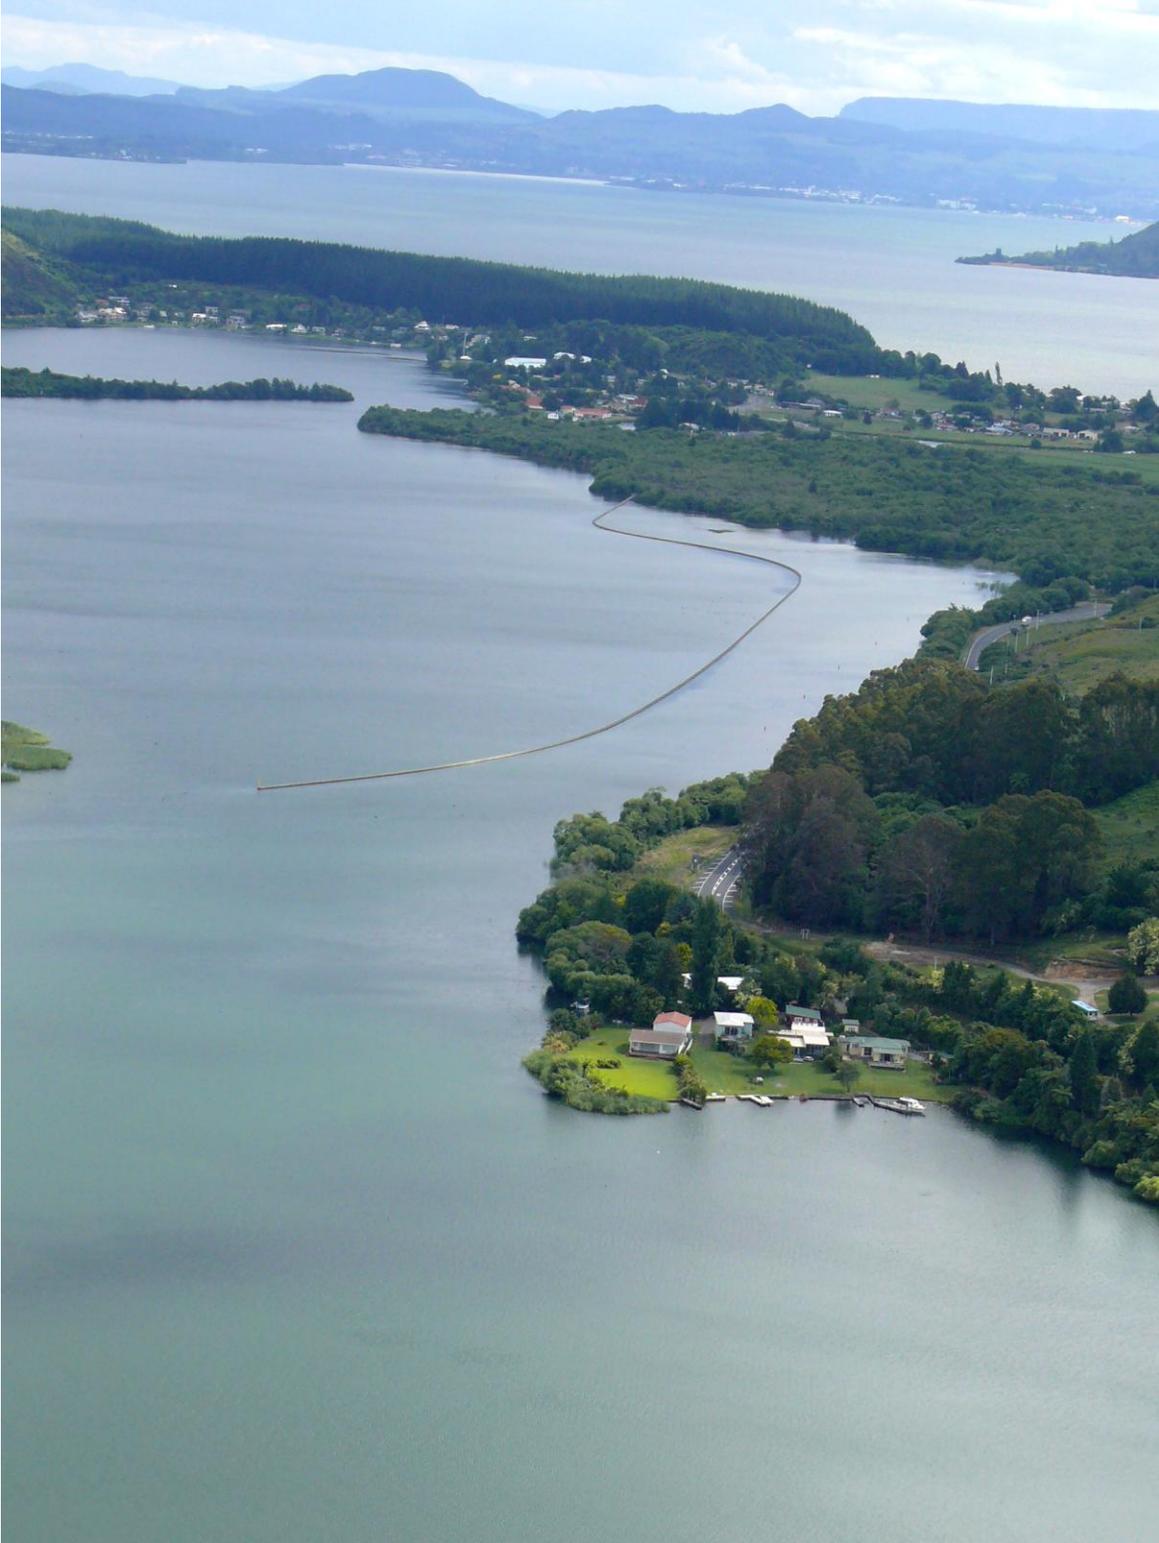
Figure 12. Photo of the Ohau Channel diversion wall, also showing Lake Rotorua (top waterbody). Photo: Environment Bay of Plenty.

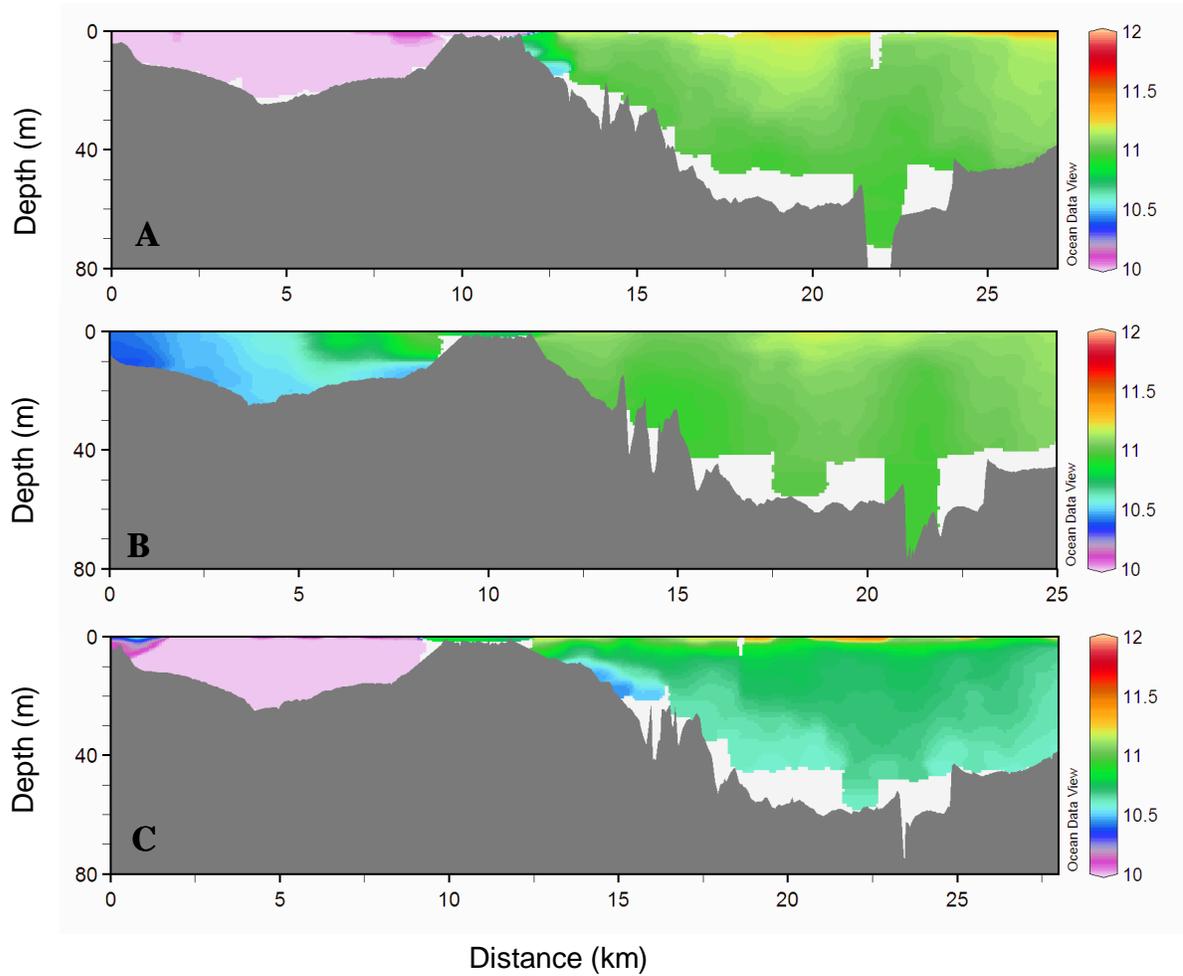
A series of figures has been used to compare 2006, 2007 and 2008 winter data arising from BioFish transects through Lake Rotorua, Ohau Channel and Lake Rotoiti. Lake Rotorua shows little vertical variation of temperature in each of the three years but a moderate horizontal gradient in 2007 (Figure 13), which may be indicative of diurnal solar heating acting in combination with south-westerly winds advecting warmer surface waters towards the north-east end of the lake in the vicinity of the Ohau Channel. The cooler water temperature near Ngongotaha in 2008 appears to be a localized phenomenon which may also be an artifact of the data interpolation scheme. There are small vertical gradients in water temperature close to the surface in Lake Rotoiti, particularly in 2006 and 2008, which are most likely due to diurnal solar heating. Water temperature was lower in Lake Rotorua than in Lake Rotoiti in all three years but the range in water temperature (10-12 °C) is small. The temperature difference in surface waters between the Ohau Channel and the western end of Lake Rotoiti was approximately 1 °C in 2006, 0.2 °C in 2007 and 0.4 °C in 2008. There was a small horizontal gradient of water temperature (c. 10.5-11 °C) from 10 to 20 m in Lake Rotoiti in 2008.

Figure 13. Water temperature (°C) for (A) 11 August 2006, (B) 29 August 2007 and (C) 26 August 2008 from a BioFish transect across Lake Rotorua from Ngongotaha to the Ohau Channel (0-10 km), through the Ohau Channel (10-12 km) to the eastern end of Lake Rotoiti (12-30 km). In (C) the diversion wall is represented by the distance from 12-13.3 km.

When cooler, denser water flows into receiving water that is warmer and more buoyant, then the denser water sinks and moves downslope along the bottom as an underflow. Conversely, warmer and more buoyant water flowing into cooler, denser receiving water spreads and flows over the surface as an overflow (Pickrill and Irwin, 1982). A number of studies (e.g., Vincent *et al.* 1986; Stephens, 2004; Hamilton *et al.* 2005) have used different temperature differentials between the Ohau Channel inflow and surface waters of Lake Rotoiti to define the occurrence of underflow or overflow conditions. When modelling the efficacy of the diversion wall designs, Stephens (2004) used a temperature differential of ± 2.5 °C, while Hamilton *et al.* (2005) used ± 1 °C to define overflow and underflow conditions. Vincent *et al.* (1986) found underflows occurred when water in the Ohau Channel was 0.2 to 0.7°C cooler than surface waters of Lake Rotoiti. The temperature difference in surface waters between the Ohau Channel and the western end of Lake Rotoiti based on BioFish transects was approximately 1 °C on 11 August, 2006, 0.2 °C on 29 August, 2007, and 0.4 °C on 26 August, 2008. There was clear evidence of an underflow in 2006, which was supported by observations of reduced conductivity and increased chlorophyll fluorescence in water adjacent to the lake bed at the western end of Lake Rotoiti. There was a hint of an underflow in the temperature transect of 2008 (Figure 13c) but this could not be corroborated by additional data (i.e. dissolved oxygen,

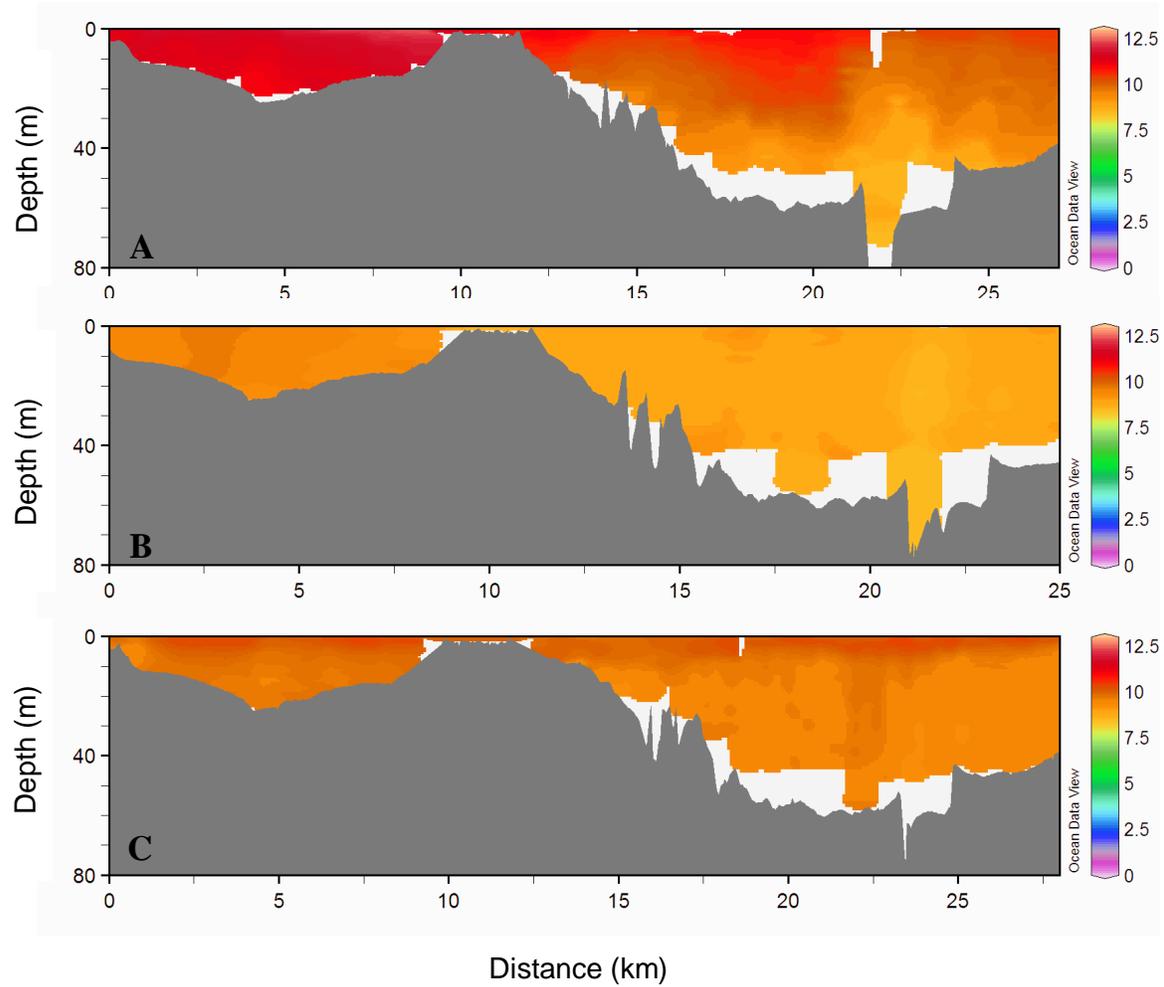
For all years, concentrations of dissolved oxygen (DO) were slightly higher in Lake Rotorua than in Lake Rotoiti (Figure 14). There was a slight tendency for DO to be higher at the water surface than in bottom waters of Lake Rotoiti but otherwise few distinctive spatial patterns.

Figure 14. Dissolved oxygen (mg L^{-1}) for (A) 11 August 2006, (B) 29 August 2007 and (C) 26 August 2008 from a BioFish transect across Lake Rotorua from Ngongotaha to the Ohau Channel (0-10 km), through the Ohau Channel (10-12 km) to the eastern end of Lake Rotoiti (12-30 km). In (C) the diversion wall is represented by the distance from 12-13.3 km.

conductivity and fluorescence) from the BioFish transect, as it was for 2006 (Figures 14, 15 and 16).

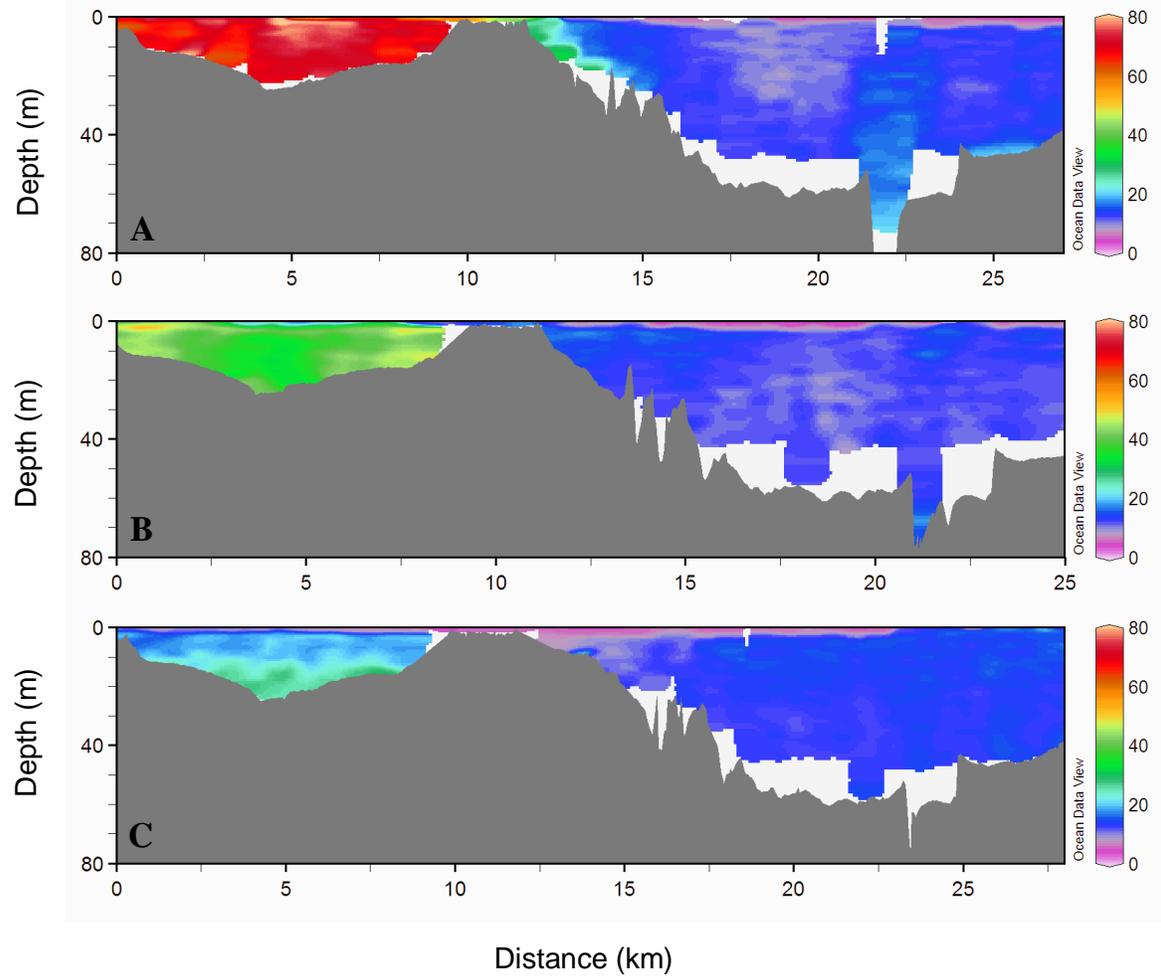
Chlorophyll fluorescence for each of the three years was higher in Lake Rotorua than in Lake Rotoiti (Figure 15). Fluorescence was especially elevated in 2006 compared with 2007 and 2008. We attribute decreases in fluorescence in surface waters (0-3 m) in Lake Rotorua in 2007 and 2008, and in Lake Rotoiti over all three years, to the effects of solar quenching; an artifact of bright light near the middle of the day quenching the emission of fluorescence by phytoplankton. An awareness of this influence is required in any analysis of fluorescence data from within these. Excluding locations where solar quenching may have been present, there was little variation in fluorescence in Lake Rotoiti except for 2006, when it was intermediate between levels in Lake Rotorua and Lake Rotoiti but elevated adjacent to the lake bed near where the Ohau Channel entered Lake Rotoiti (Figure 16). Conductivity is generally slightly higher in Lake Rotoiti than in

Figure 15. Fluorescence for (A) 11 August 2006, (B) 29 August 2007 and (C) 26 August 2008 from a BioFish transect across Lake Rotorua from Ngongotaha to the Ohau Channel (0-10 km), through the Ohau Channel (10-12 km) to the eastern end of Lake Rotoiti (12-30 km). In (C) the diversion wall is represented by the distance from 12-13.3 km.

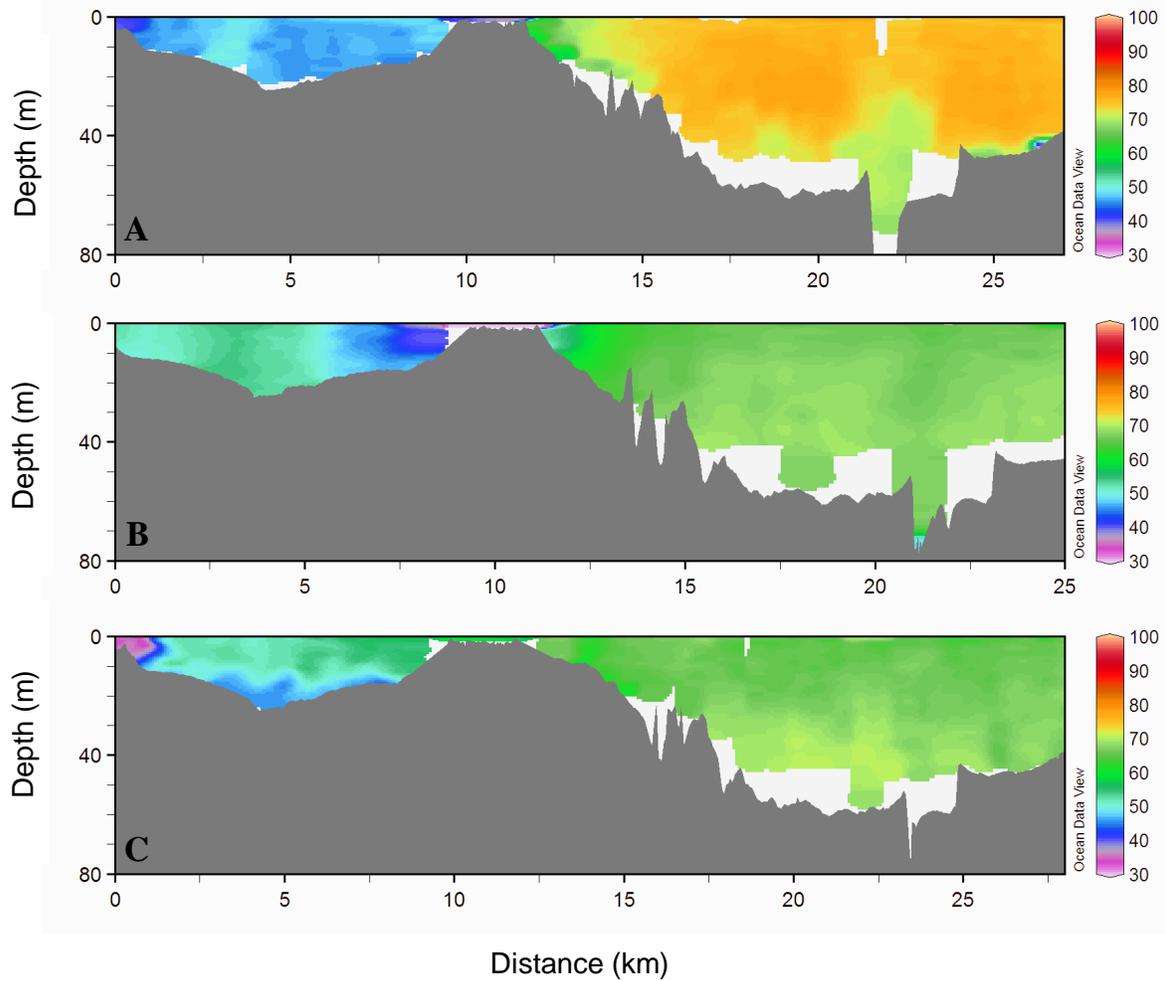
Lake Rotorua. For 2006 it is possible to track the underflow of water from the Ohau Channel into the western end of Lake Rotoiti as a signature of water with lower conductivity. No such indication is given by the conductivity transects of the subsequent two years.

Figure 16. Conductivity ($\mu\text{S cm}^{-1}$) for (A) 11 August 2006, (B) 29 August 2007 and (C) 26 August 2008 from a BioFish transect across Lake Rotorua from Ngongotaha to the Ohau Channel (0-10 km), through the Ohau Channel (10-12 km) to the eastern end of Lake Rotoiti (12-30 km). In (C) the diversion wall is represented by the distance from 12-13.3 km.
